Manhole Inspection Summary

Manhole # S15QQ1012MH

Insp Date: **7/17/07 3:16 PM**

Location Address: **5024 YELLOWWOOD AVE**

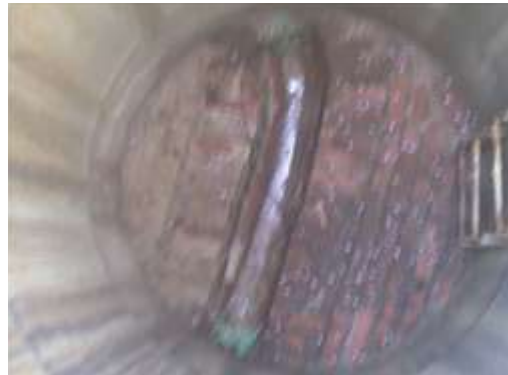
Top View

Bench debris.

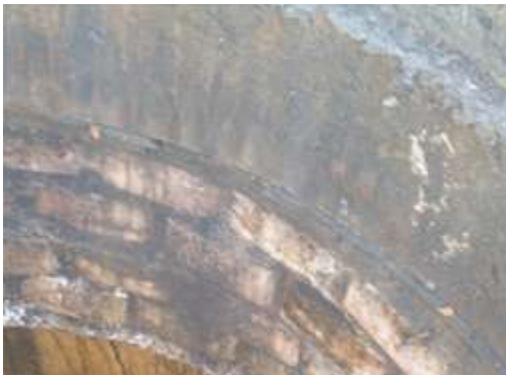
Defect

Frame leaks. Adjustment and Corbel infiltration.

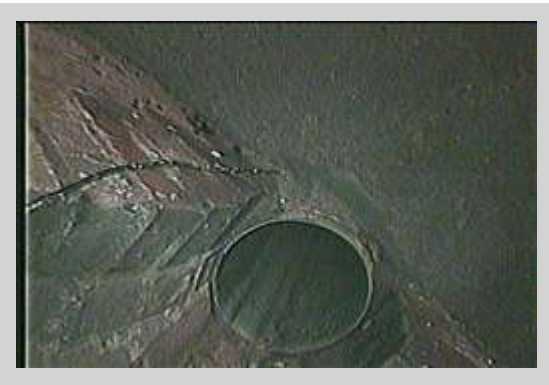
8 in. Circular Gravity Sewer Pipe Out @ 12 O'Clock

Infiltration: **Evidence** Pipe Seal Cond: **Cracked**

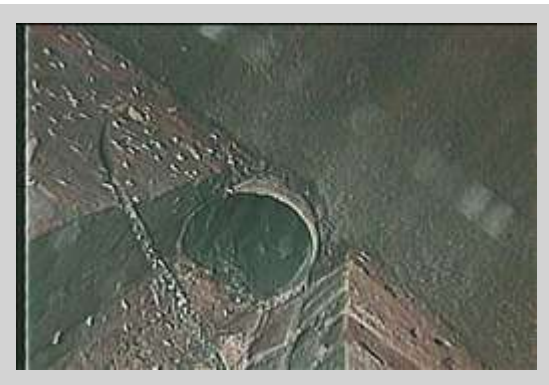
8 in. Circular Gravity Sewer Pipe In @ 6 O'Clock

Deposits: ☐ None ☒ **Mud** ☐ Sludge ☒ **Debris** ☐ Grease

Silt Depth: **1** (in.) Deposits Extent: **Light**
